YOUR COMMUNITY

HOA RESERVE STUDY

Report Number: 10-001
Site Inspection Date: April 14, 2010
Report Submittal Date: May 1, 2010

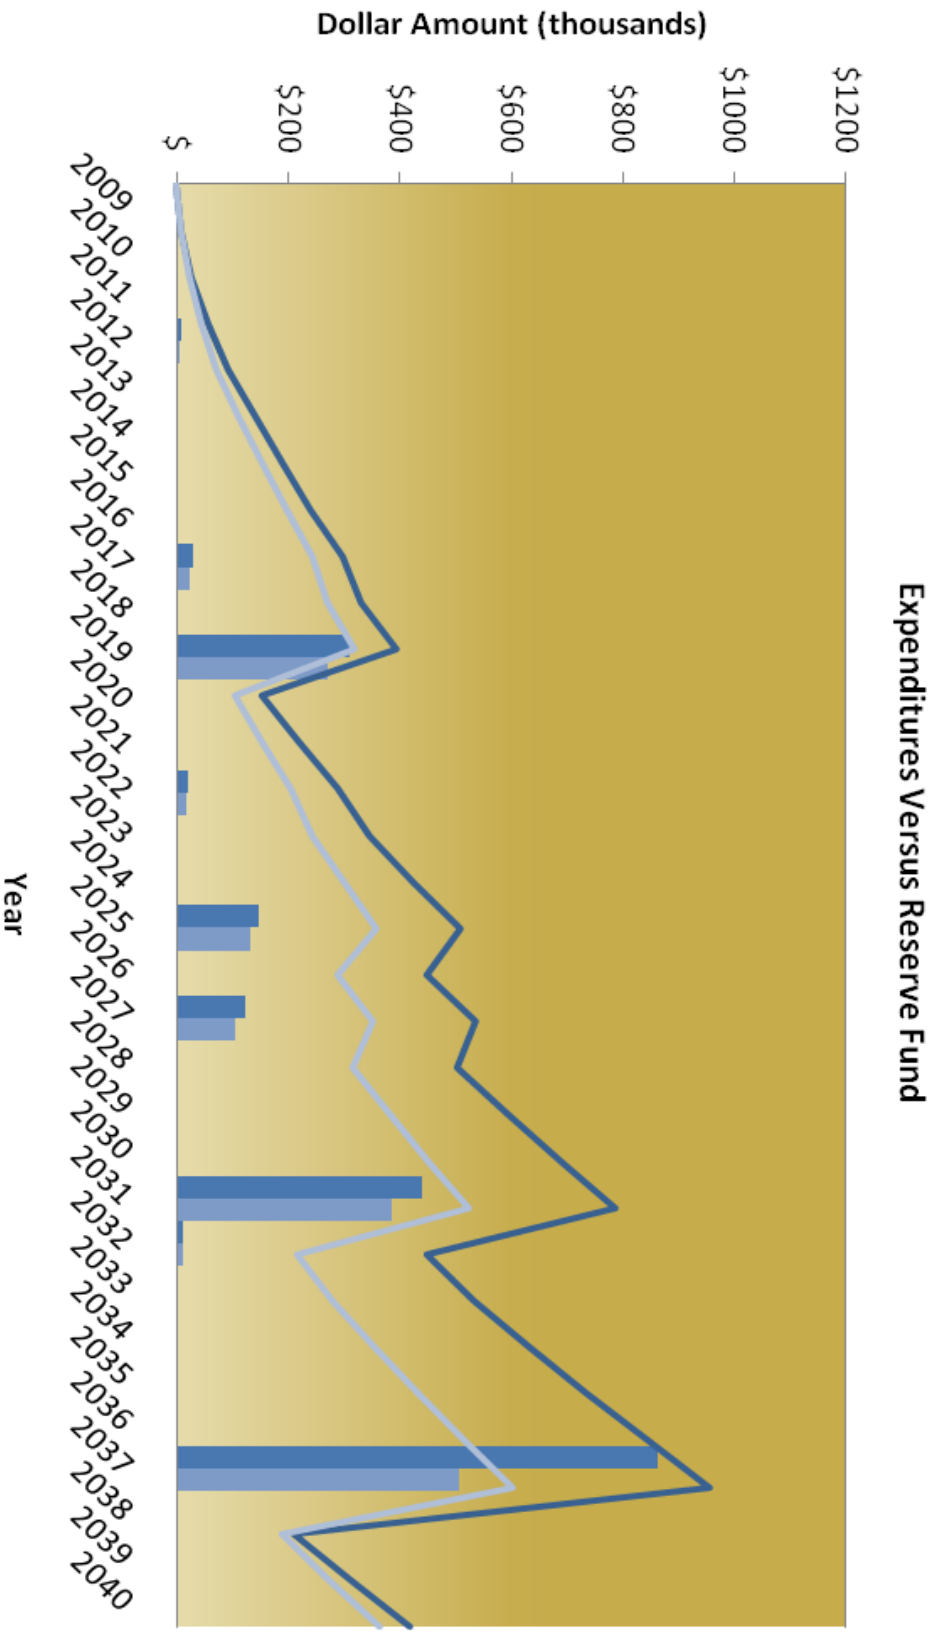
Figure 1.1 – Expenditures versus reserve fund for high and low component costs.

Figure 1.1 is a graphical representation of expenditures over the thirty year reserve study period. The light and dark blue bar columns represent anticipated expenditures based on the lowest, best cost scenario, and the high cost scenario, respectively. The corresponding light and dark blue lines indicates the capital in the reserve fund for the low and high expenditures, respectively, according to unit allotments recommended.

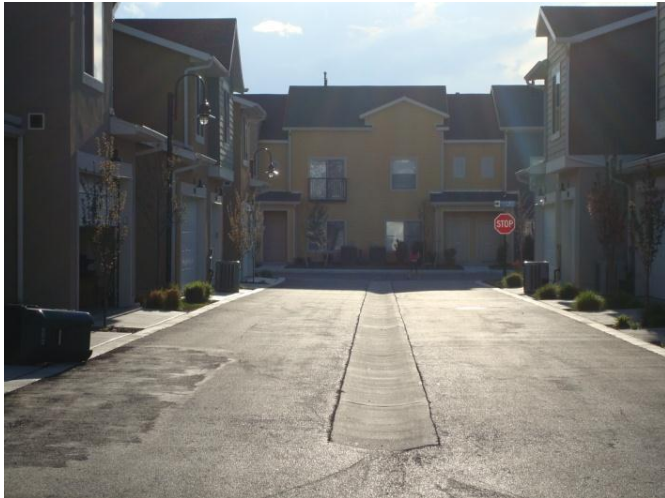
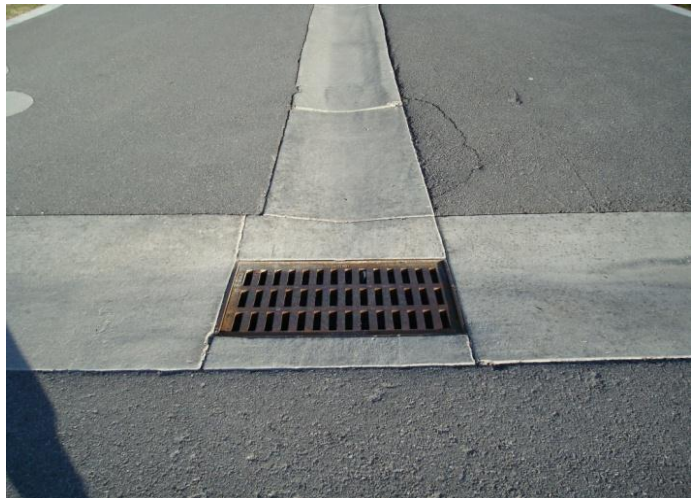
Component Name: Asphalt Slurry Seal
Component Number: Drive Materials 1002

Component Life Expectancy: 5 years
Age of Component: 3 years
Remaining Component Life: 2 years

The asphalt appeared to be in good condition with minor cracking. A slurry seal is recommended within the next two years. Slurry seal will help protect the asphalt from degradation by sealing cracks, preventing water seepage and damage. It also rejuvenates the surface and renews the oils, keeping the asphalt from becoming overly brittle.

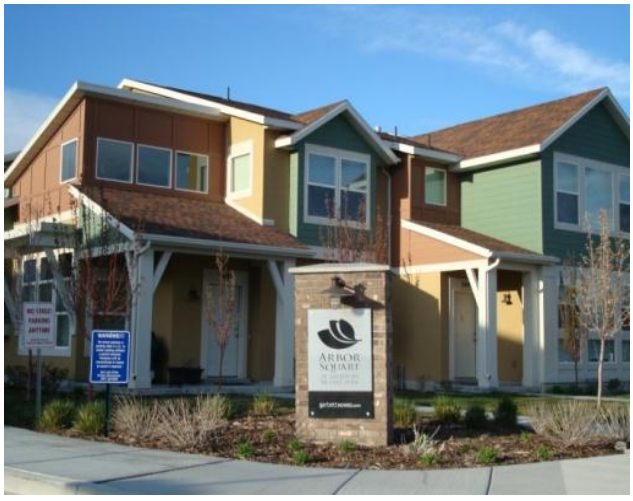
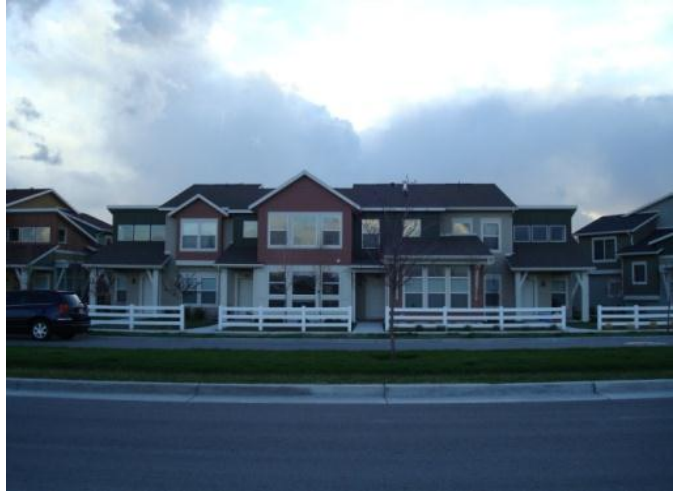
Component Name: Roof
Component Number: Roofing 9001

Component Life Expectancy: 30 years
Age of Component: 3 years
Remaining Component Life: 27 years

The roof was installed in 2007 and from the ground appears sound. No leaks or issues have been reported by the homeowners to property management. This asphalt shingle roof has a 30-year life span, and is recommended to be replaced between 2026 and 2028.
